Manhole Inspection Summary

Manhole # S2111_019MH

Insp Date: **5/5/08 9:33 AM**

Location Address: **2701 rittenhouse rd**

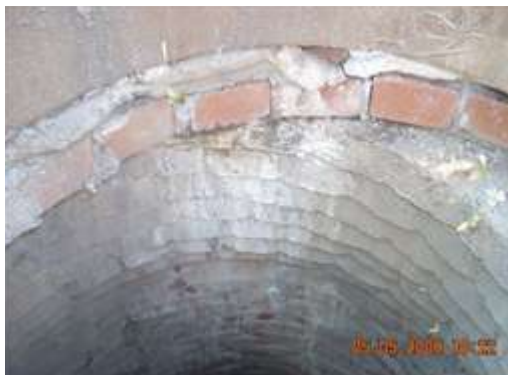
Defect 3

Frame Offset: **2.5** (in.) Condition: ☐ Sound ☐ Cracked ☒ **Leaks**

Infiltration: ☐ None ☒ **Joint** ☐ Cracks ☐ Mortar ☐ Roots ☐ Wall

infiltration @ chimney/frame joint

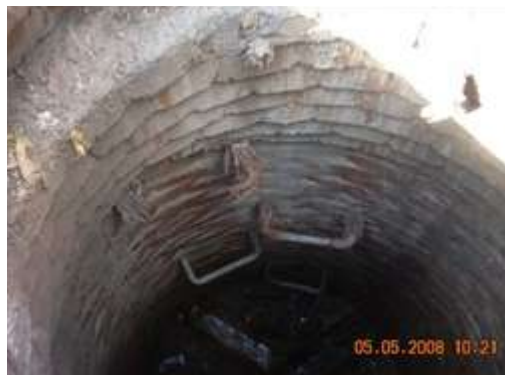
Defect 2

Steps Count: **3** Missing: **2** ☒ **Corroded**

corroded and missing steps

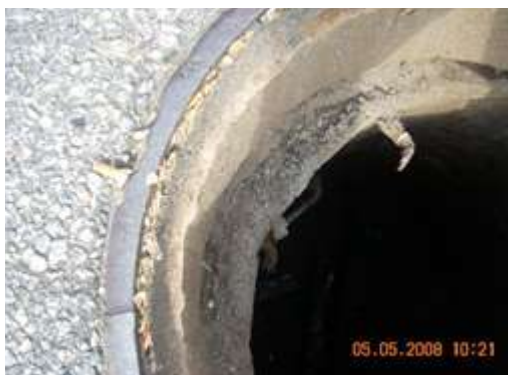
Defect 1

frame offset

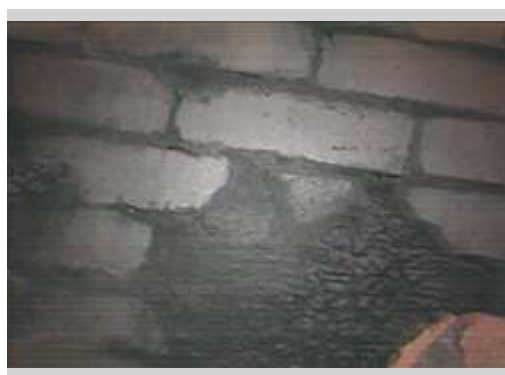
Defect 6

Infiltration: ☐ None ☐ Joint ☐ Cracks ☐ Mortar ☐ Roots ☒ **Wall**

infiltration @ barrel wall

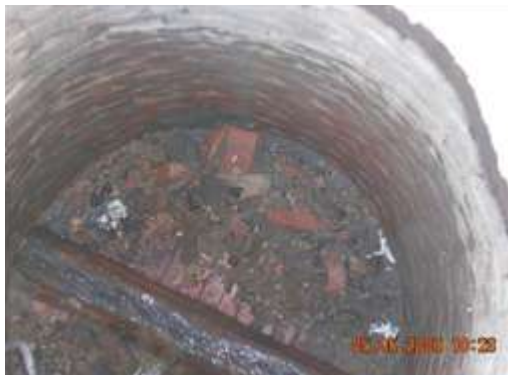
Defect 5

Condition: ☐ Sound ☐ Cracked ☐ Root Intrusion ☐ Deteriorated ☐ Leaks ☒ **Debris**

debris on bench

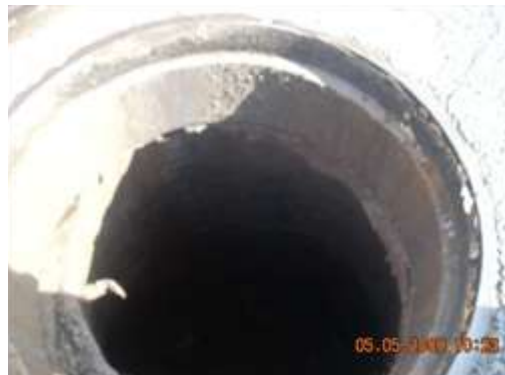
Defect 4

Subject To Ponding: **Sheeting**

inflow evidence from sheeting
